# Arthur R. Marshall Loxahatchee National Wildlife Refuge

Wetland Field Project  
Wetland and Riparian Ecology FW479  
Denise Valentin  
August 25, 2021

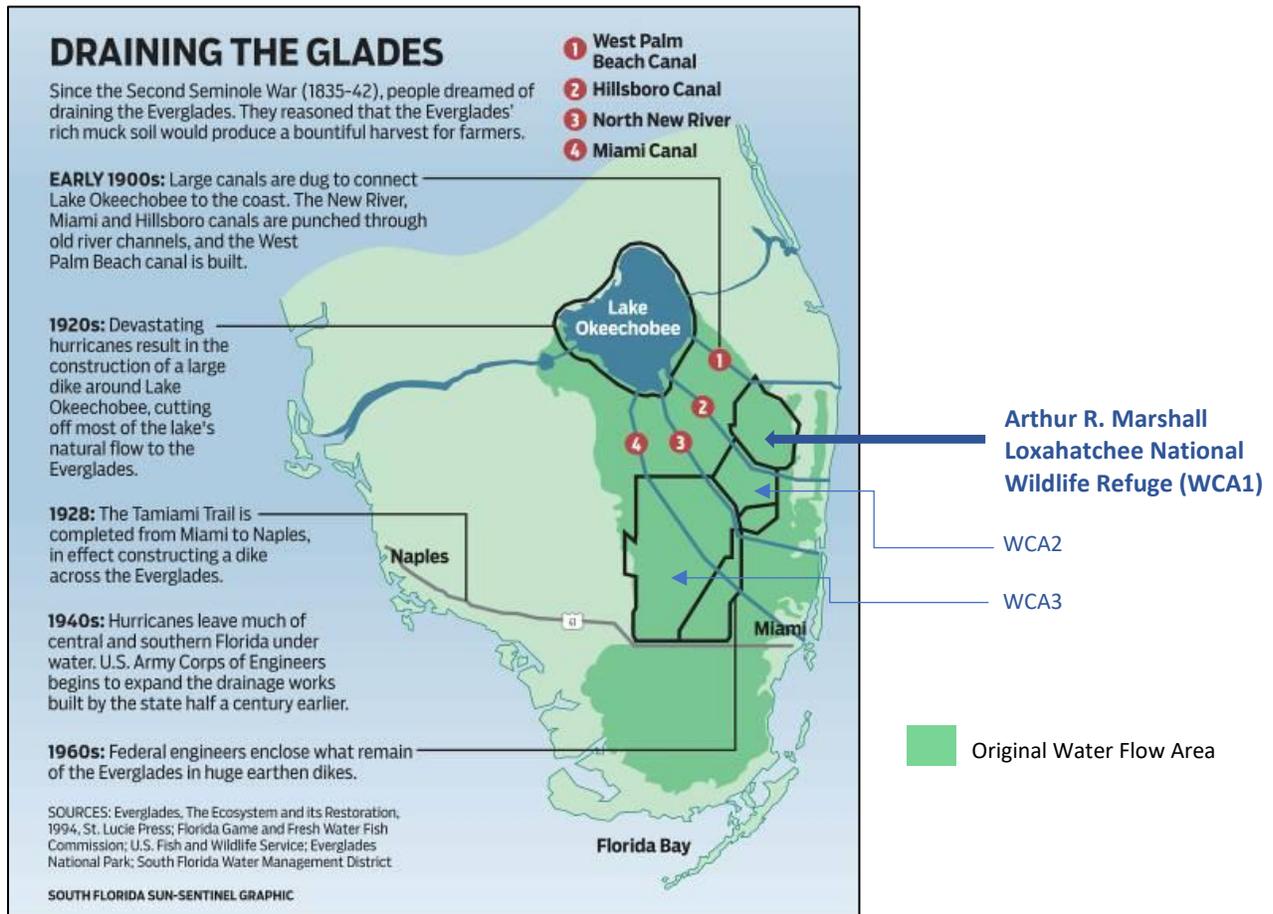
Then work began on draining the marshes below Lake Okeechobee. The highly rich muck soil that had been found in this area attracted farmers, and the land was changed for agricultural needs. Drainage canals continued to be built between 1913 and 1927, further destroying the water flow to and around the Everglades. The St. Lucie River on the east was then channeled and connected to Lake Okeechobee from 1916-1925. More water was now being sent to the west and east coasts, and less to the Everglades.

Fig 2. Draining the Glades  
 Source: Lemaire and Sisto (2012)

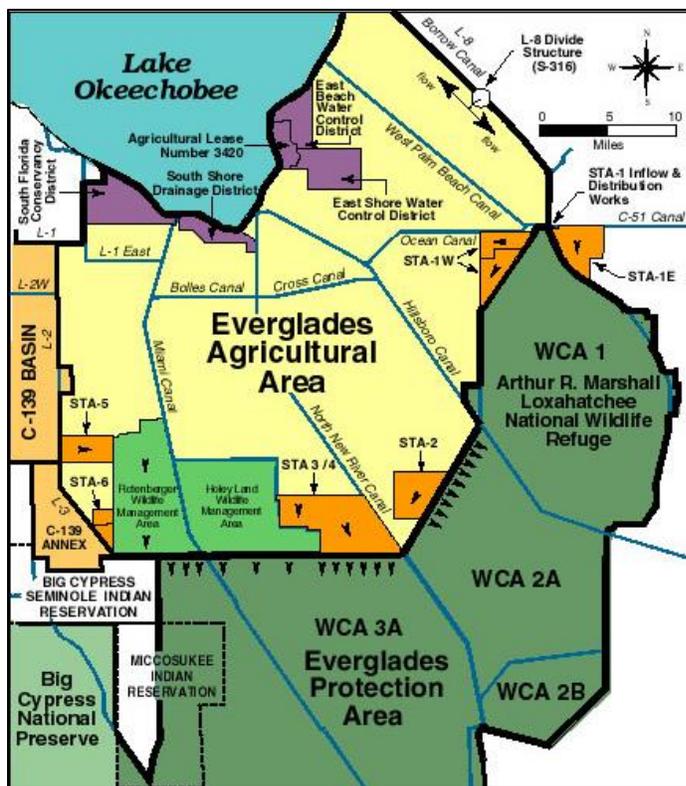
Fig. 4 Compartmentalization of the Everglades  
 Source: Walker, W. and Kadlec R. (2008)

Because canals have broken up the land, the original sheet flow of the Everglades has for the most part vanished. Above average precipitation seasons can cause areas to be under water, damaging plants and animal habitats. Above average dry seasons can lower water levels damaging soils and plants, which makes food scarce for animals.

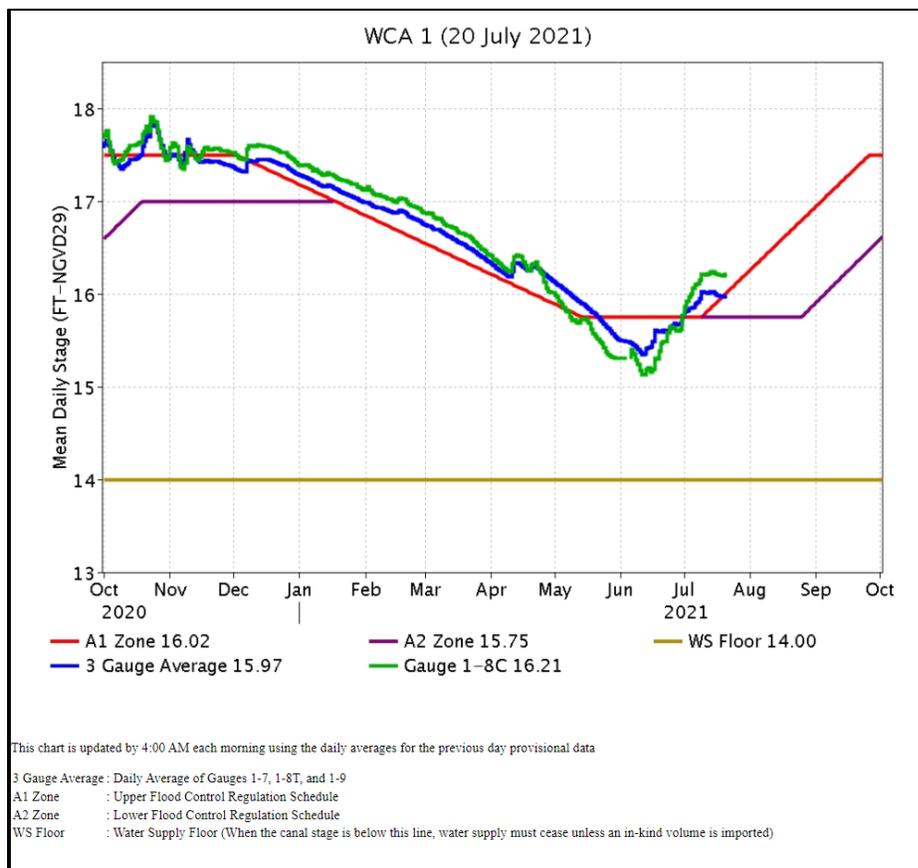
Fig. 5 – Hydrograph WCA1 (ARM Loxahatchee NWR) – Central Portion  
 Source: SFWMD.gov

Fig 5. shows the hydrograph for the central portion of the Refuge. The A1 and A2 zones show the flood control regulation schedules. For the most part, the water level amounts are near those schedules, but as you get to May and June, the amounts recorded are below average. Also, starting at mid-July, the water levels are not rising as forecasted.

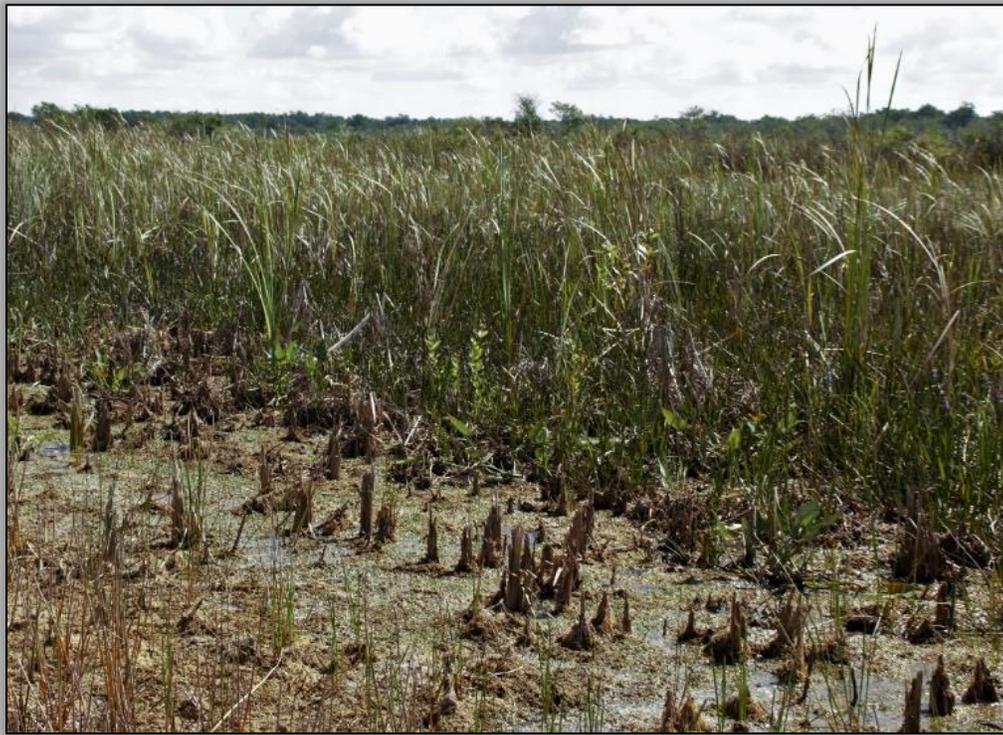
Wetland soils are hydric soils due to a loss of oxygen from water. There are two types of soils found in wetlands: organic and mineral. The soil we found in Impoundment B in the Refuge was organic. After reviewing the Web Soil Survey, we found our soil was Okeelanta muck. Okeelanta muck ranges from moderately alkaline to strongly acidic. These soils are found in freshwater marshes and depressional areas of Southern Flatwoods and Southern Florida Lowlands. They have rapid permeability and are poorly drained. (National Cooperative Soil Survey 2014).

Photo 1 – Soil Sample Landscape in Impoundment B at ARM Loxahatchee NWR

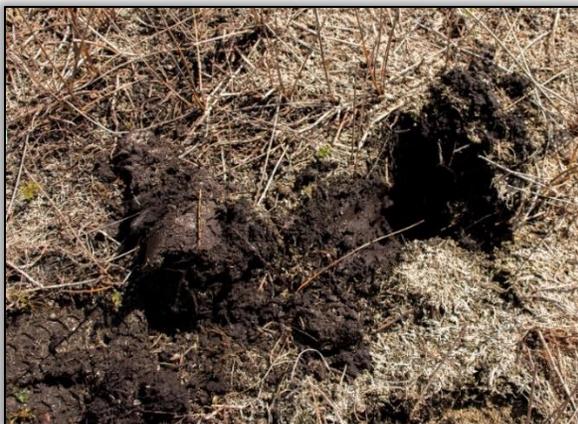
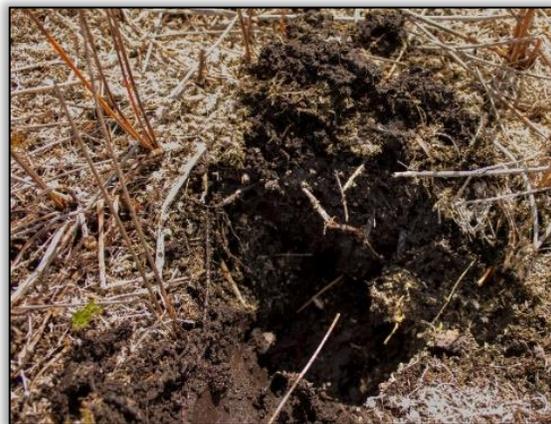
Photos 2 and 3 – Soil Samples taken at Impoundment B at ARM Loxahatchee NWR  
Source: Denise Valentin

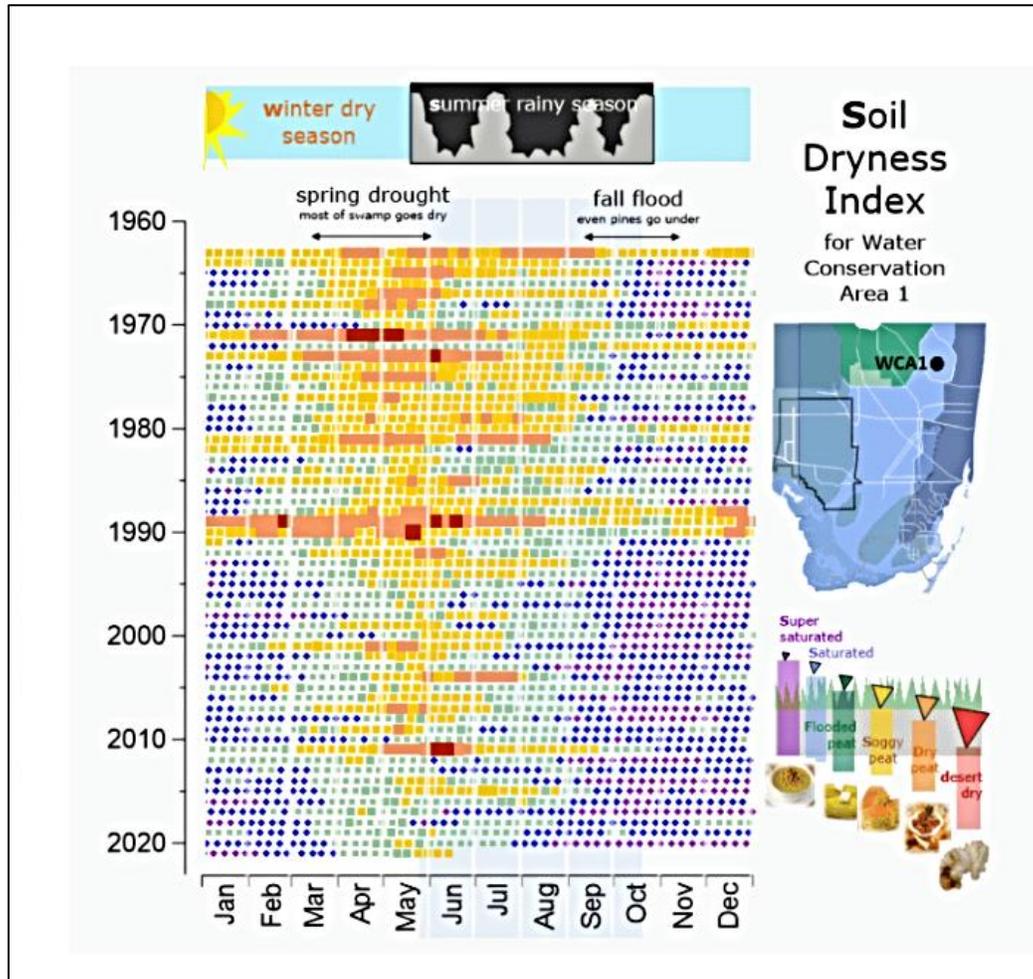
Fig 6. Soil Dryness Index for WCA 1 – ARM Loxahatchee NWR  
 Source: GoHydrology.org

Fig. 6 shows that back in 1960 the soils were mostly soggy or dry peat, with a few desert dry months. In the 1970's and 1980's, the soil starts getting a little more flooded. As we get to 1989, the peat becomes dry again for half of the year and soggy for the other half. The 1990's shows an increase in soil saturation and less dry peat. 2000-2020 shows very little dry peat and more supersaturated soils.

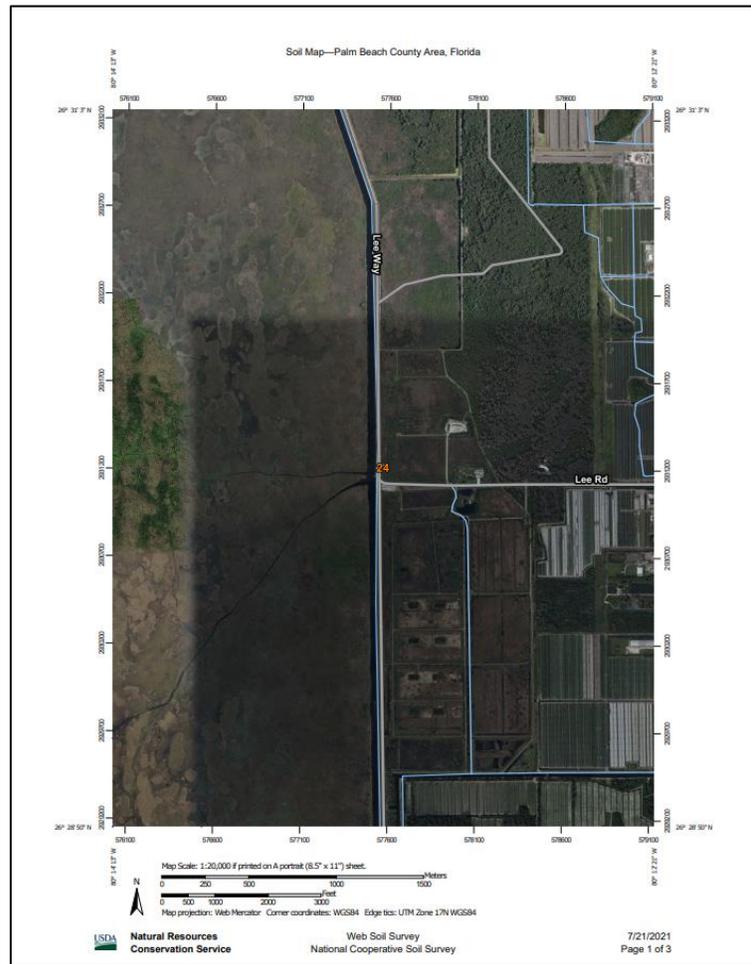
Map Unit Symbol	Map Unit Name	Acres in AOI	Percent of AOI
24	Okeelanta muck, drained, frequently ponded, 0 to 1 percent slopes	0.1	100.0%
<b>Totals for Area of Interest</b>		<b>0.1</b>	<b>100.0%</b>

Fig 7. Web Soil Survey for ARM Loxahatchee NWR  
 Source: National Cooperative Soil Survey

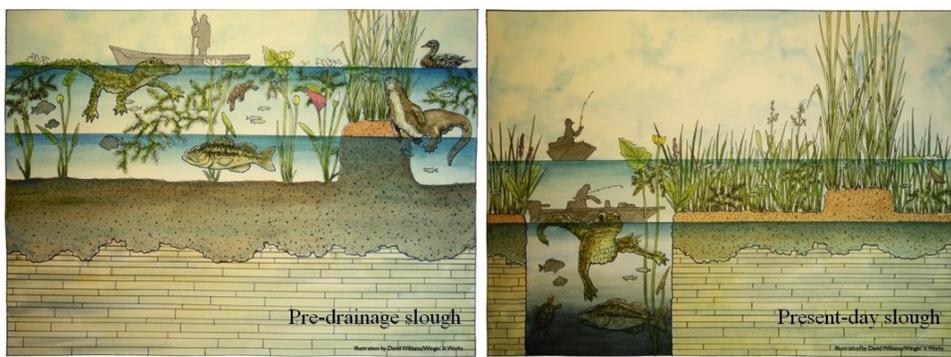
Canals, levees and pump stations now control the water level at the Refuge. The outer perimeter of the Refuge itself is a canal. According to Harvey et al. (2019), canals and levees affect the connectivity at the landscape scale. They decompartmentalize the Northern Everglades (aka the Refuge) and affect the flow of nutrients and pollutants. Canals also pull water from the surrounding wetlands causing reduced water levels throughout the Refuge.

Fig. 9 – Canals draw water from the surrounding wetlands  
 Credit: Christopher McVoy, SFWMD

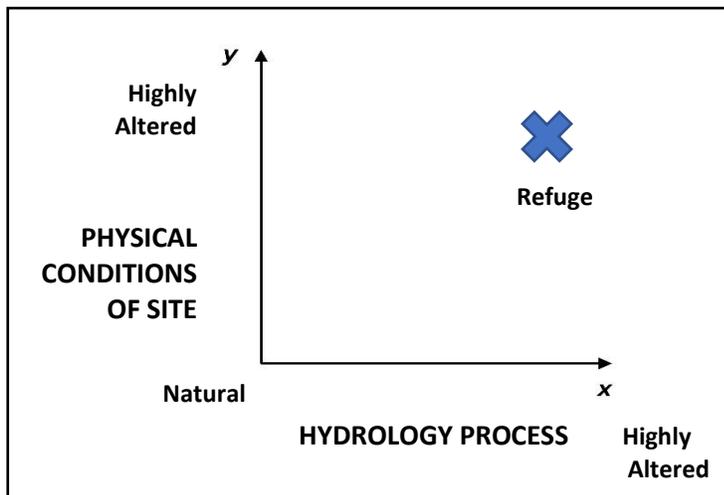
As such, the waterflow at the Refuge has been changed. Since the hydrology has been highly altered, this has caused physical conditions at the Refuge to be highly altered also. Currently, water levels are now monitored and controlled to bring back the proper waterflow. The impacts to the ecosystem has degraded wildlife habitat and reduced the richness of wildlife species.

Fig. 9 – Conceptual model for the hydrology process and physical conditions of the Refuge  
 Credit: Denise Valentin

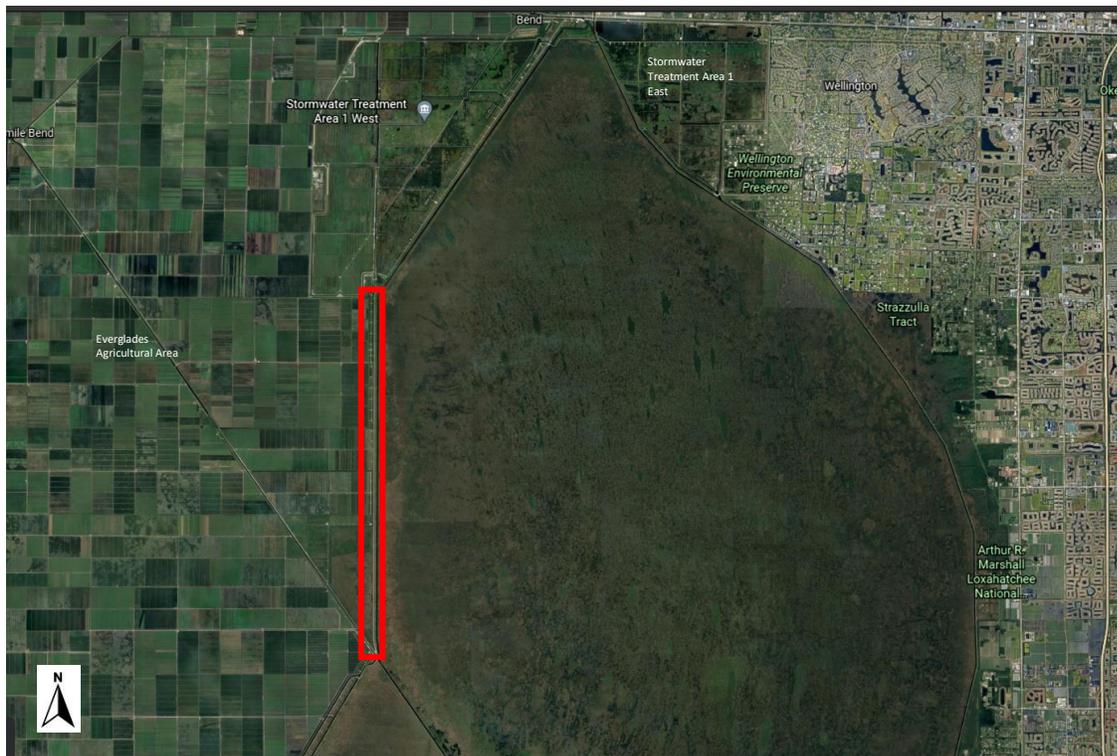
Fig. 12 – A.R.M. Loxahatchee National Wildlife Refuge and surrounding agricultural area and developments.  
Credit: Google Earth

4. Since the canals negatively affect the waterflow and the water levels of the surrounding wetlands, a section of Canal 7 below the STA-1W should be filled. Studies would then be immediately performed on the changes in water quality, levels of contaminants, soil characteristics, and plant, animal, and aquatic organism populations.

Closing this portion of the canal will also close a portion of the agricultural land that borders the Refuge on the west side. The intent of this recommendation, is to allow the flow of water to slowly meander through the Refuge and allow better filtering of the water. It will also allow succession of the correct plant communities while flooding out nonnative species.

Water will still flow to WCA 2 through spillways at the southern portion of the Refuge. The Levee beside the closure area will still remain to protect the outer areas from flooding. Access to this area will still be available by motor vehicle and air boat.
